Progress Report

STUDIES ON THE CAUSES AND PREVENTION  
OF ERRATIC CRACKING IN CONCRETE PAVEMENTS

November 1, 1961

Work Order No. 60-13NN14  
Lab. Auth. No. 5039-S-55

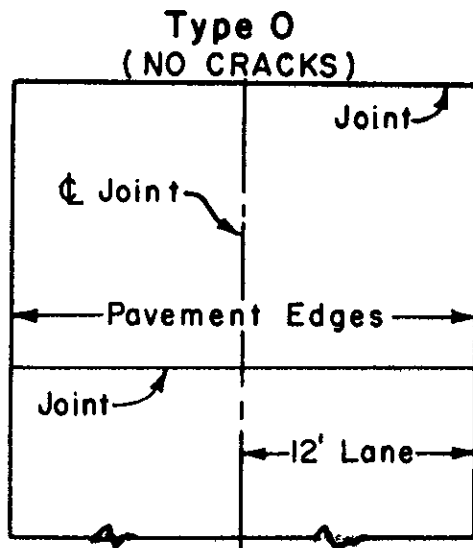
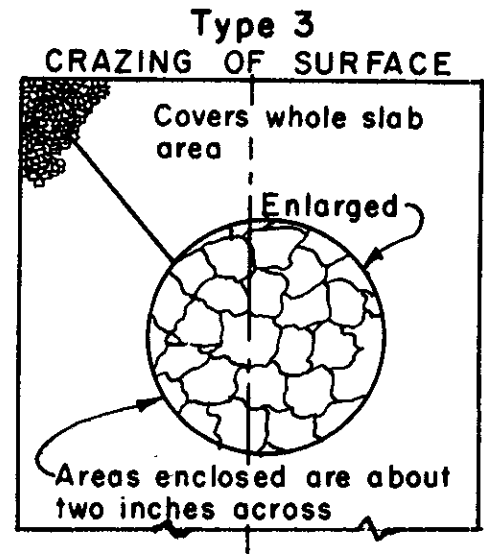
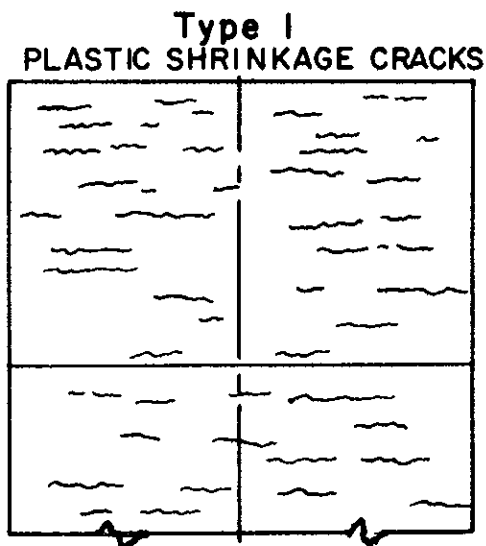
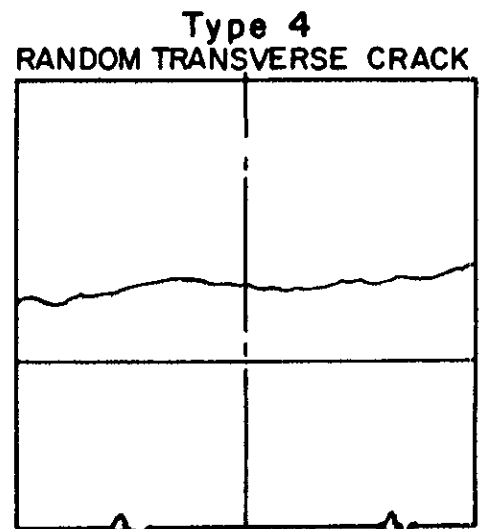
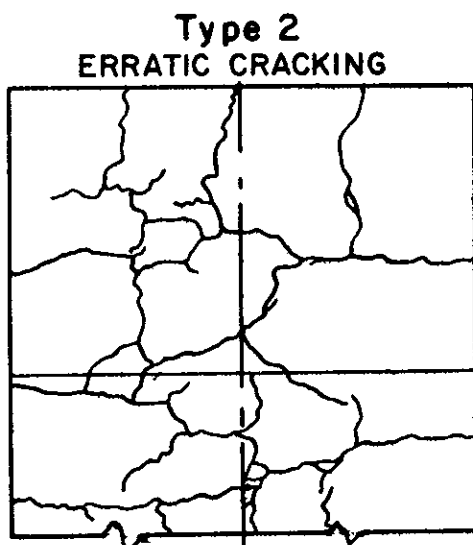
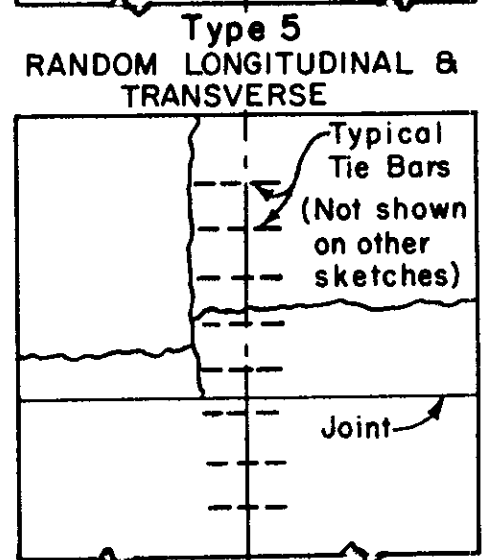
Figure 1

This investigation is being conducted in accordance with verbal instructions from Mr. J. W. Trask, Assistant State Highway Engineer, Operations, in August, 1959. The investigation is financed in part with Federal funds. For the purpose of this study, "erratic" cracking is defined as deep seated cracking having no pronounced orientation with respect to the margins of the pavement. The areas enclosed by the cracks, and/or the pavement margin usually being from about 10 to 75 square feet. For convenience in discussion, erratic cracking is designated as Type 2. See Figure 1.

Most of the pavements contain cracking of some type. The different types are broadly classified and illustrated in Figure 1, and the occurrence of the type of cracking found in each pavement is shown in Table 1.

GENERAL CLASSIFICATION OF CRACKING IN PCC PAVEMENTS
